Voltage Measurement Errors as a result of Multiple VT Groundings

F. Uriondo¹, G. Aguirre¹, J.R. Hernández¹ and J.M. García²

Abstract. On 12 December 2007 a distance relay tripped erroneously by zone 1 for a ground fault in an adjacent line. RTDS simulations and theoretical calculations proved that the relay had operated according to its design parameters and that the settings of the units involved were adequate. Further analysis of the fault recordings showed that the currents followed a single-phase to earth fault pattern, whereas the voltages did not follow any known pattern for the conventional types of faults.

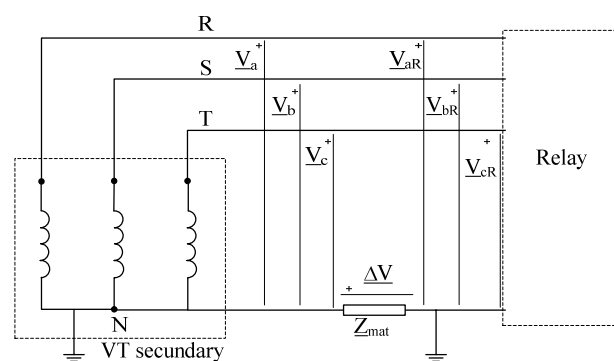
When the VTs are grounded both at the VT location and at the relay location (usually in the relay housing) the situation illustrated in Figure 1 arises.

As it is shown in the paper the situation can go unnoticed since direct sequence voltages measured in the relay housing are measured correctly in spite of the multiple grounding because the ΔV component of the voltages does not affect this measurement. In fact, only the zero sequence voltages measured in the relay housing are affected.

Fig. 1. Groundings in VT and relay locations.

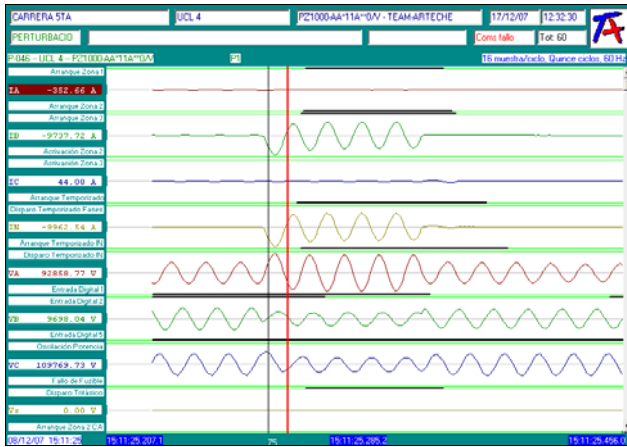
Fig. 2. Fault Data Record.

The actual fault data record is presented in Figure 2 and the corresponding phasors in Figure 3. It can be seen that the currents follow a phase B to ground fault pattern (the phase B and neutral currents acquire much higher values than load current) but the voltages show a very awkward response. The A phase voltage almost doubles the pre-fault value while phase B and C voltages shrink from

normal pre-fault values to fault voltages. In the case of the "C" phase that reduction in the voltage is not associated with a higher current in that phase. This effect can only take place in a weak infeed situation but the current of phase B clearly shows that it is not the case.
