# Power Quality Impact of Wind Farms on Domestic and Industrial Facilities

**Abstract.** The objective of this paper is to evaluate the impact of a nearby Wind Farm on Power Quality at local domestic and industrial facilities. Adequate, specialized measuring equipment made it possible to measure several quantities and assess the main Power Quality parameters with special incidence on Flicker and Harmonics levels.

As mentioned, this measurement campaign aimed at evaluating the impact on power quality of the electrical supply on the domestic and industrial facilities located in the proximity of the Monte Carrio Wind Farm located in the region of Pontevedra, Galicia, Spain.

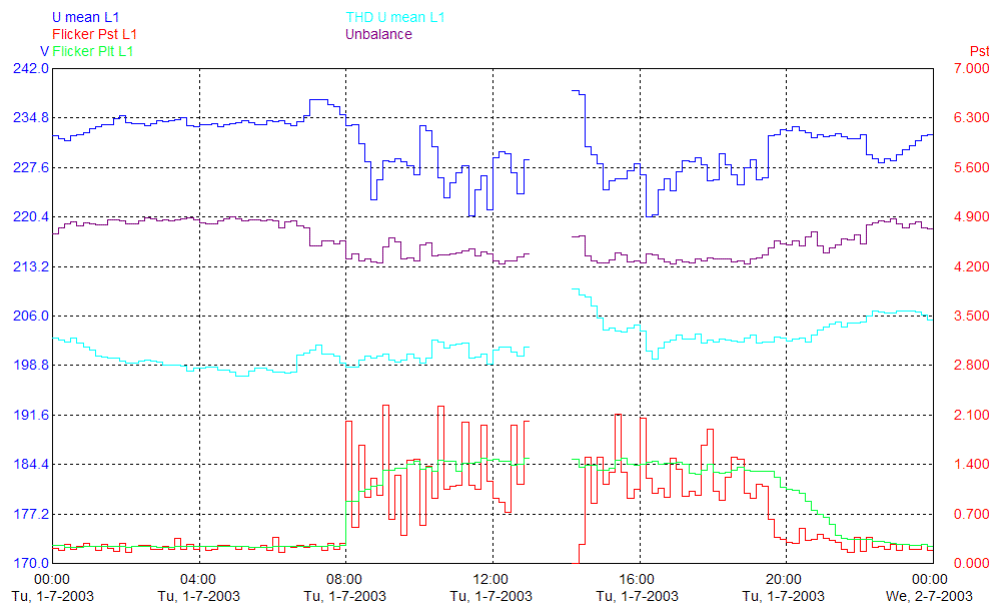
Fig. 1. Several power quality parameters measured at the sawmill over 1 day

Harmonics present relatively small values, as can be seen in figures 1 and 2 by the aggregate European THD values. Still, dominant harmonics are the usual 3<sup>rd</sup>, 5<sup>th</sup> and 7<sup>th</sup> harmonics.

The three phases appear balanced with similar flicker values in all phases. The flicker is definitely the most delicate issue as it highly surpasses the limits set by the standard. This can also be observed in figures 1 and 2.

A quick look at figure 1 provides unequivocal clues to the origin of flicker values there encountered. Flicker seems to have a “daily routine” as it starts to have significant values at about 8 a.m. every weekday morning, stops for lunch at about 1 p.m., resumes at 2 and finally decreases at about 7:30 p.m.. Weekends are clearly rest days as flicker values are comparable to night values on weekdays.

This clearly shows flicker values are strictly linked to the working hours of the facility.

At the sawmill the flicker levels suggest “internal causes”, i.e. flicker is caused by electrical equipments at the site and not so much by the nearby wind farm. This can be observed taking into account the low flicker levels at night time.

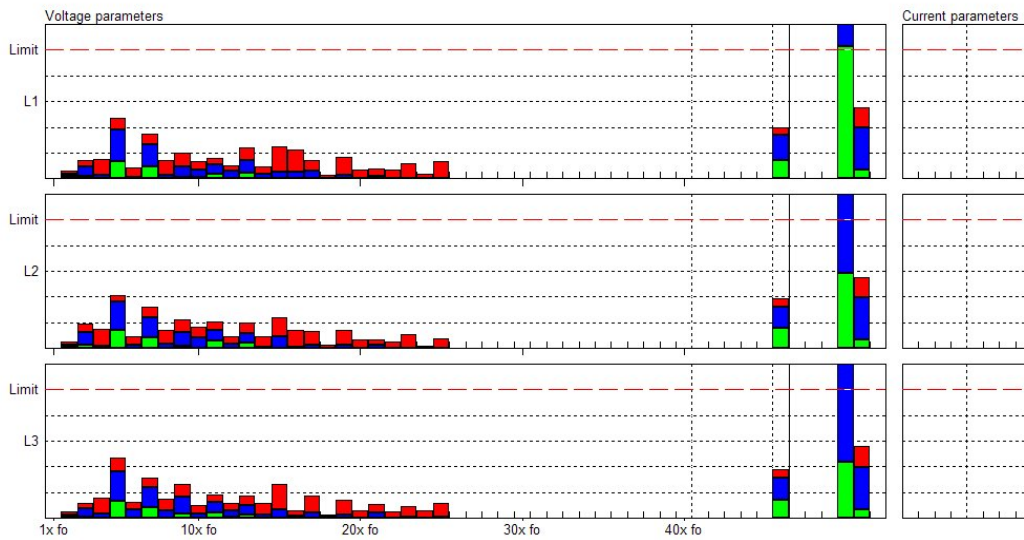
Fig. 3. Harmonics, THD, flicker  $P_{st}$  and unbalance cumulative frequencies measured at the restaurant

Figure 3 shows an interesting overview of the measurement campaign in this particular site. It shows the cumulative frequencies of harmonics, European total harmonic distortion (THD), short-term flicker ( $P_{st}$ ) and voltage unbalance levels. Most values are similar in the three phases, but oddly enough, phase one has higher flicker levels when compared to the other two, as can also be observed in figures 4 and 5.

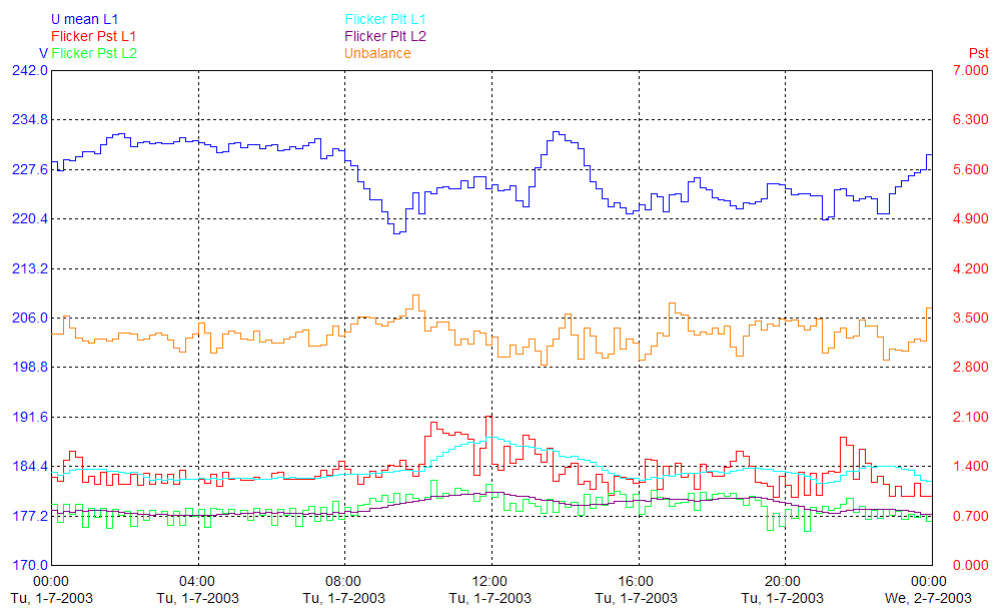
Fig. 4. Several power quality parameters measured at the restaurant over 1 day

Flicker levels in all phases are high above the reference values set by the applicable standards. Contrary to what happened at the previous measurement site, flicker levels here cannot be easily linked to restaurant activity or working hours.

At the restaurant the flicker levels are most likely due to “external causes”, either the nature of the grid or the nearby wind farm, since there seems to be no “internal causes” that can explain the high levels of flicker.

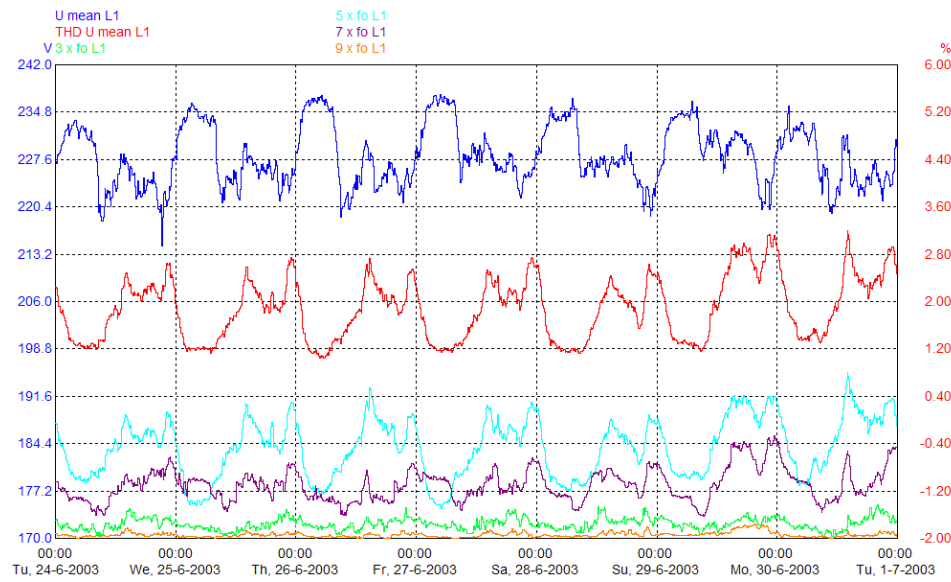
Fig. 6. Several other power quality parameters measured at the restaurant over 1 week

Also, dominant harmonics 3<sup>rd</sup>, 5<sup>th</sup>, 7<sup>th</sup> and 9<sup>th</sup> have relatively small values, as shown in figure 6. Voltage unbalance is quite low and within the admissible normative values, despite the “flicker unbalance”.

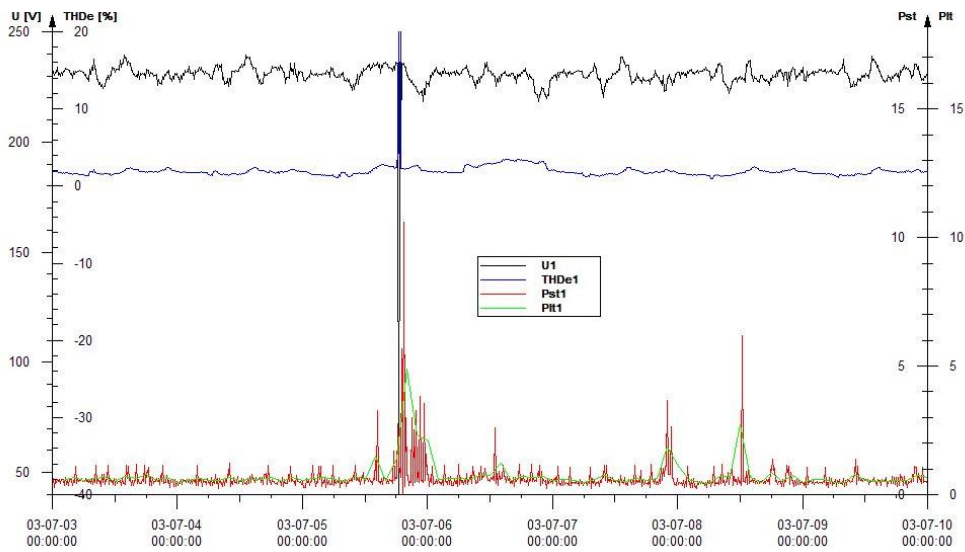
Fig. 7. Some power quality parameters measured at the domestic residence over 1 week

Flicker levels are somewhat above those set by the standard. Figure 7 depicts some power quality parameters, highlighting an unusually high value of flicker registered shortly after a 100% voltage dip.

At the domestic residence, the flicker levels are also above the limit given by the standard and the possible origins are the same as in the restaurant.
